Fracture Analysis of a Cycloidal Gearbox as a Yaw Drive on a Wind Turbine

J. A. Martins: E. C. Romao Introduction

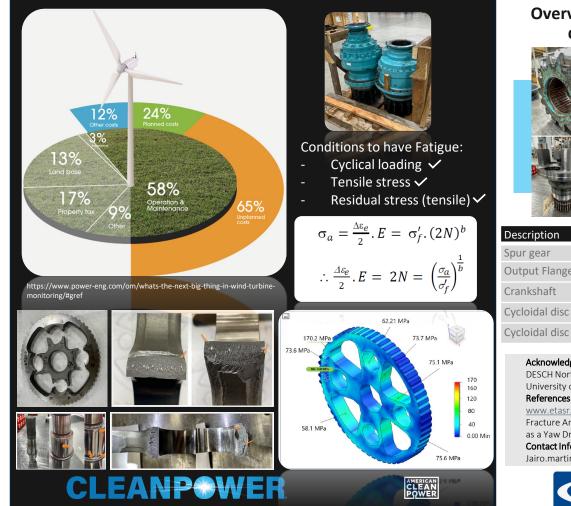
Overview of the yaw drive parts

Description	Condition	Hardness
Spur gear	Preserved	55 HRC
Output Flange	Preserved	220 HB
Crankshaft	Deformed	59 HRC
Cycloidal disc (OD)	Broken	60 HRC
Cycloidal disc (ID)	Broken	55 HRC
