Prospective Case Series on the Efficacy of Antimicrobial Laminated Poly Electric Scaffold on Bacterial Loads of Chronic Ulcerations through Fluorescence Imaging

Raymond J. Abdo, DPM, CWS
St. Louis Foot & Ankle, St. Louis, Missouri

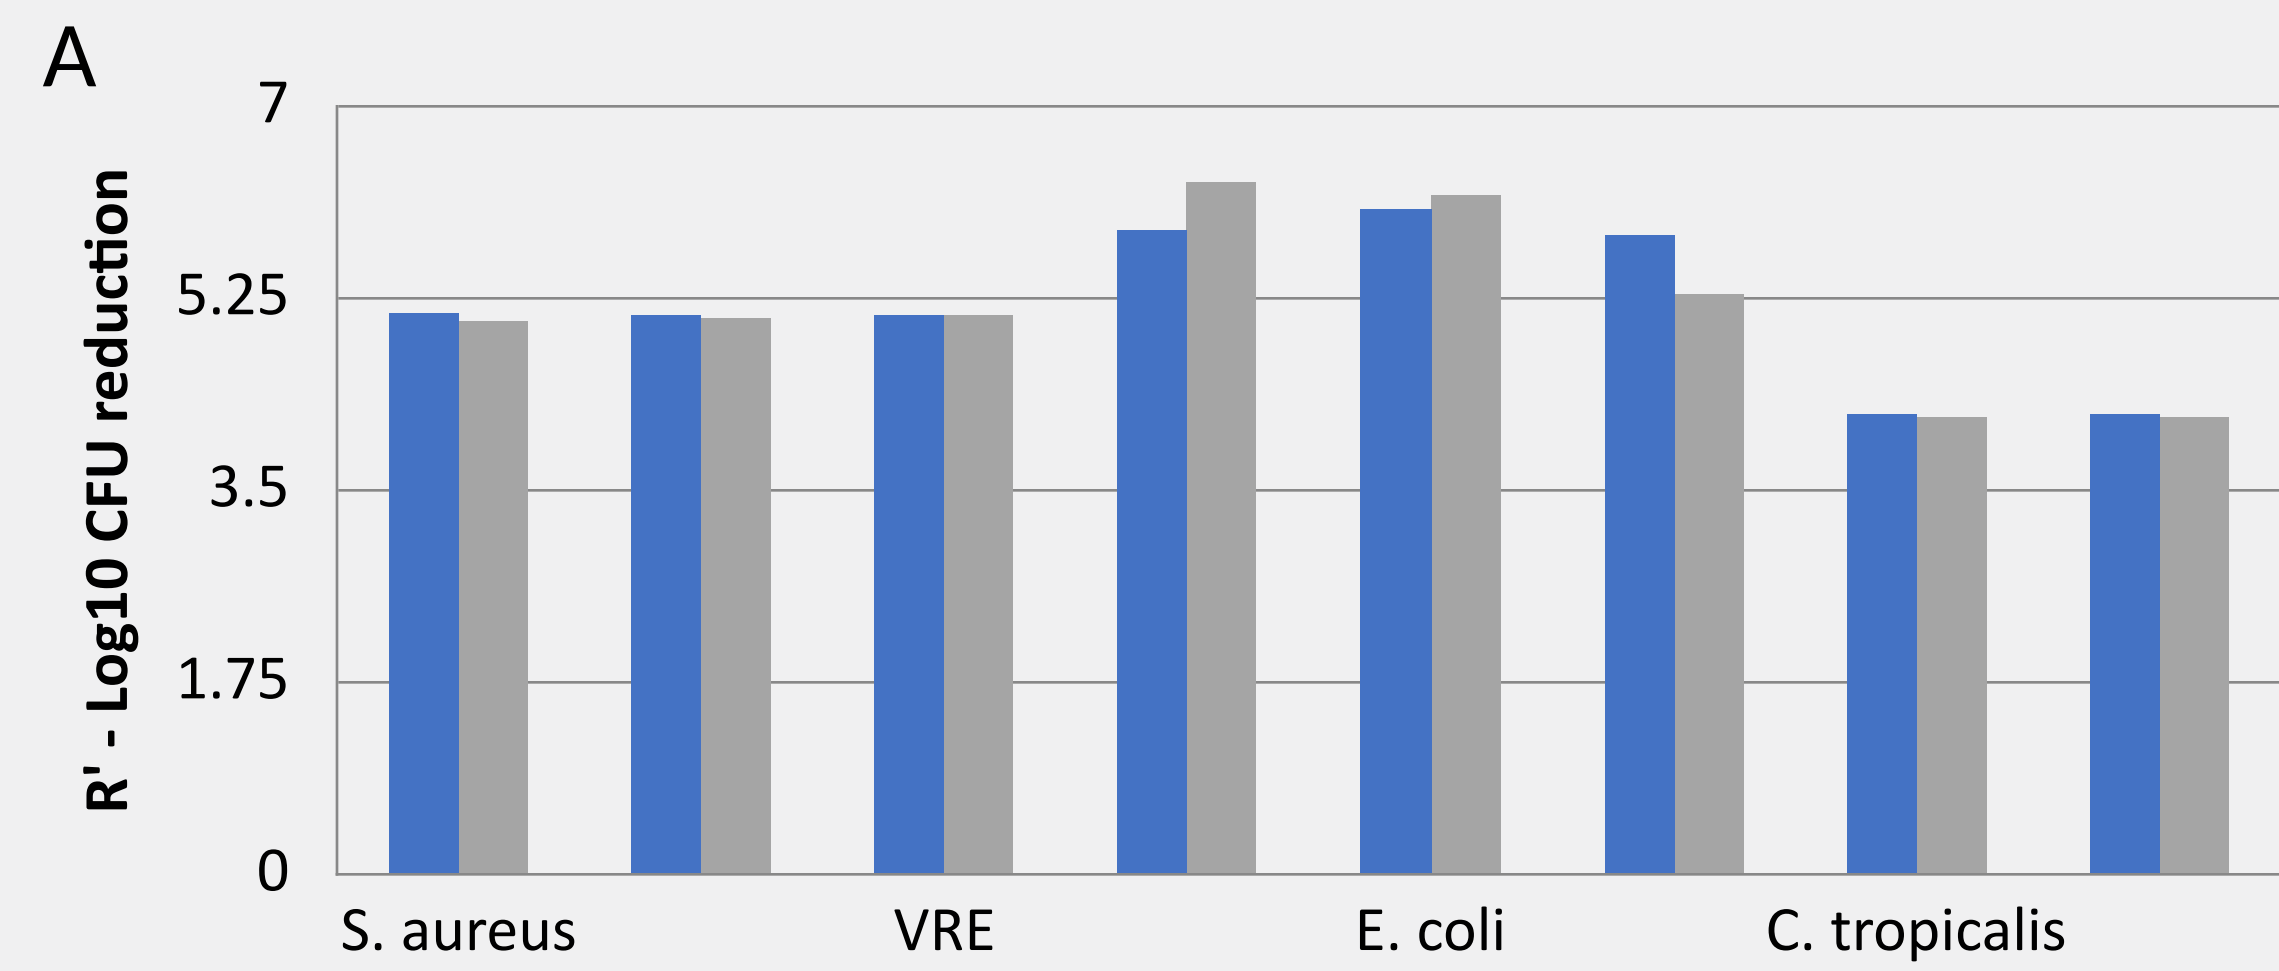
Figure 1: A) The Matrix provides a 4- to 6-log reduction in a variety of bacteria and yeast, including MRSA and VRE.^{1,2} B) Mechanism of action of a bioresorbable silver matrix. Unlike conventional silver dressings, the Matrix contours to the microtexture of the wound bed allowing active ingredients to be effective at low doses.³ C) The mechanism of action of the Matrix is designed to facilitate improved wound healing.³

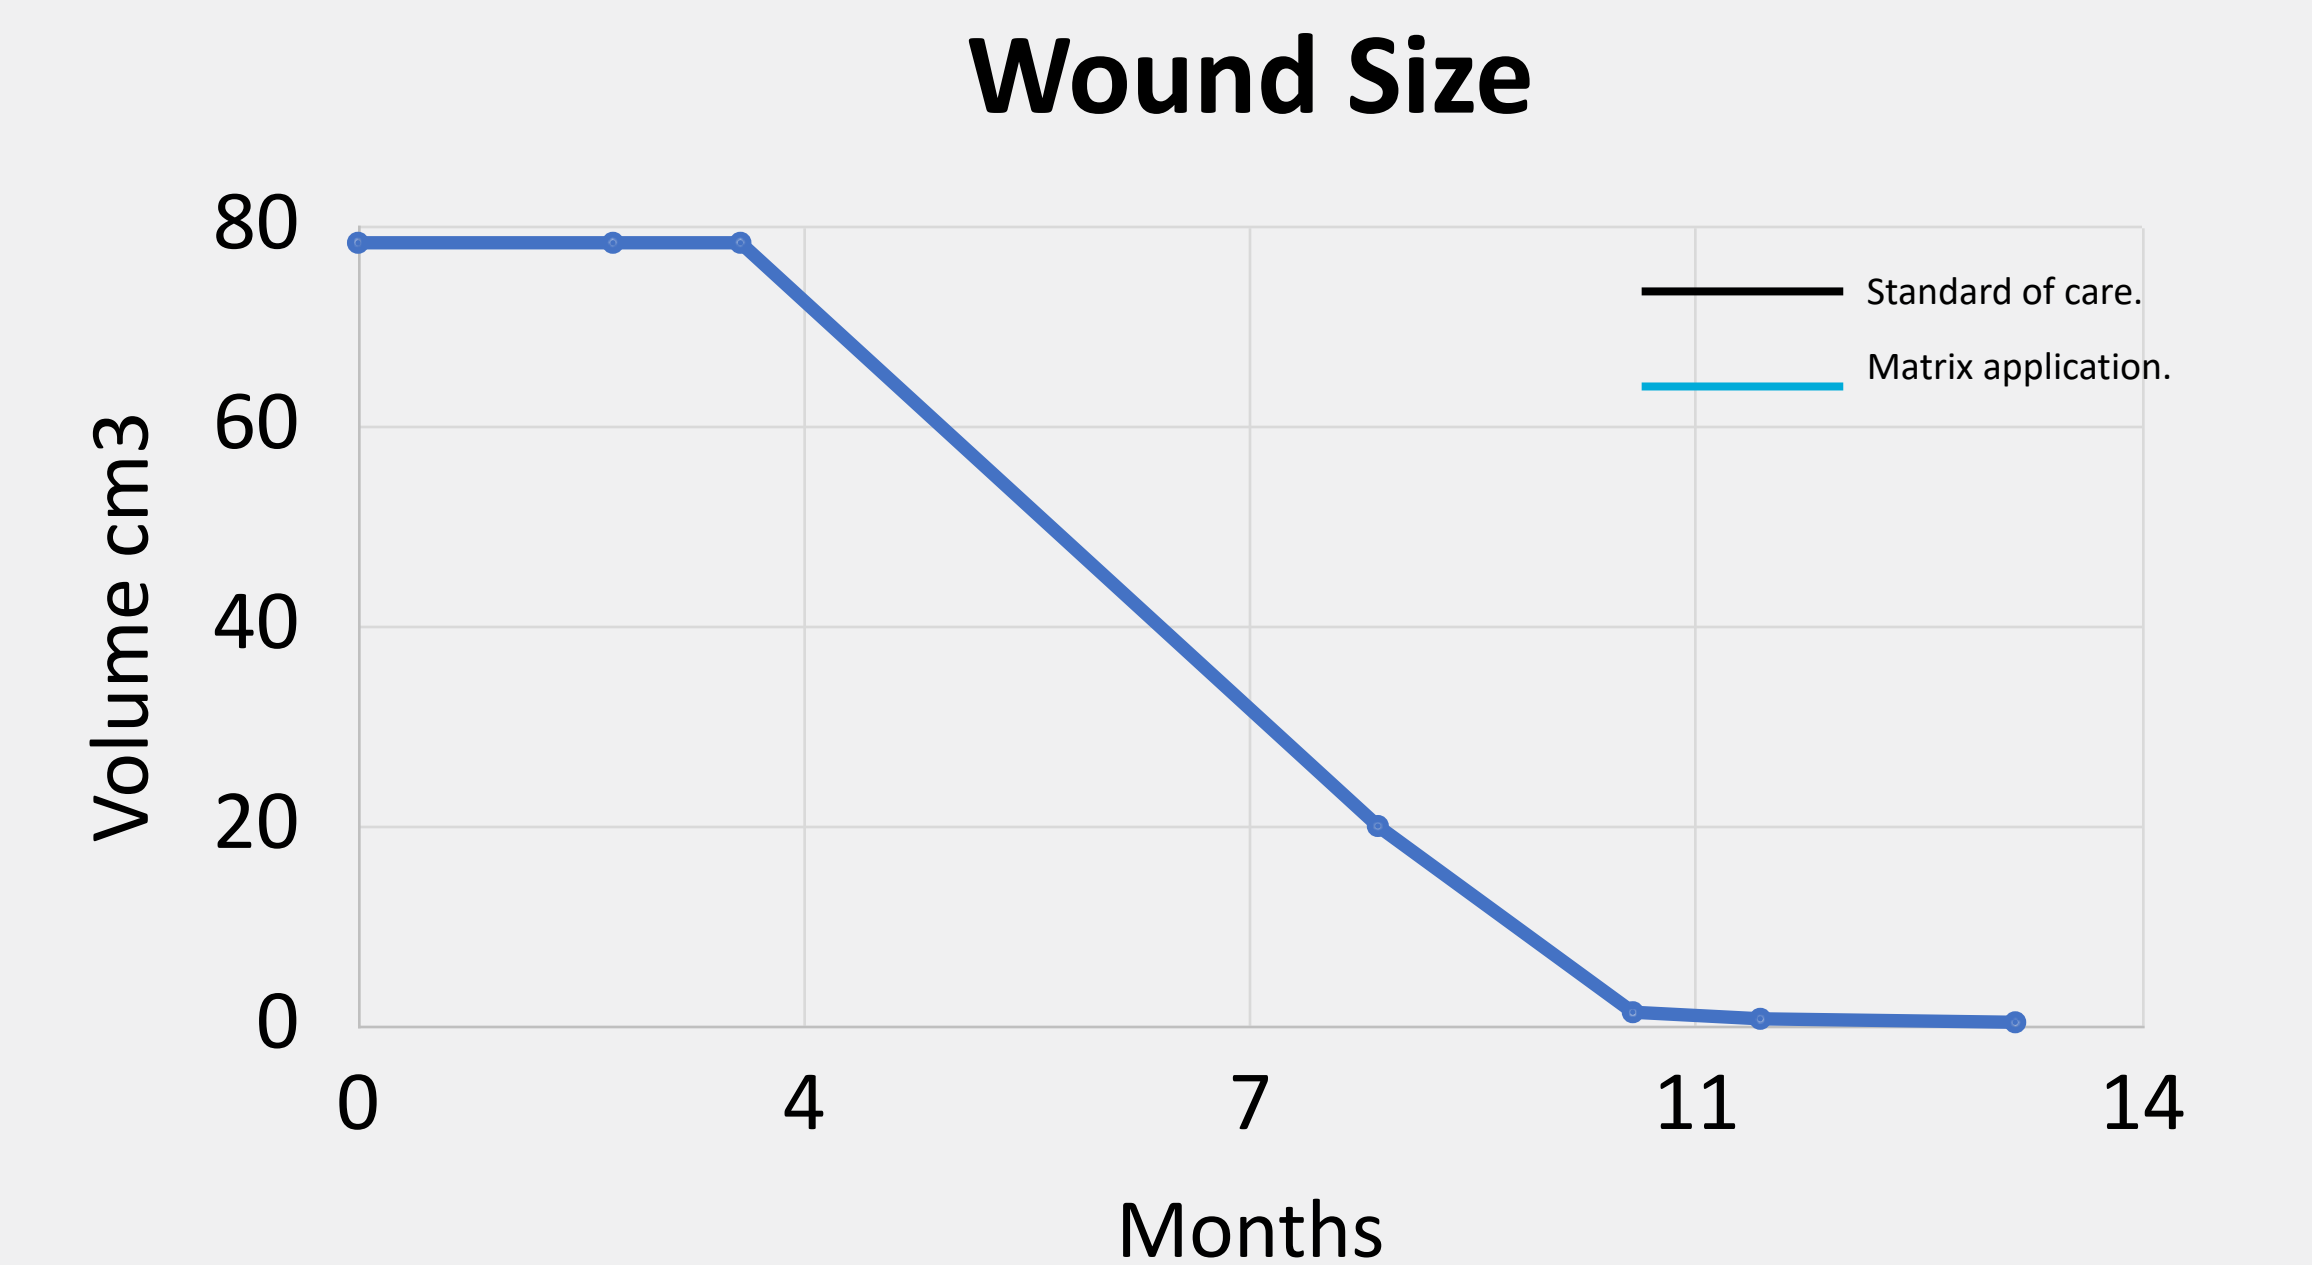
Figure 3: The healing trajectory of the wound over ___ months. Bright blue lines indicate period of Matrix application.
