Exploring the Potential of Amnion Membrane Allografts

via Mobile Multispectral Near-Infrared Spectroscopy: A Case Series

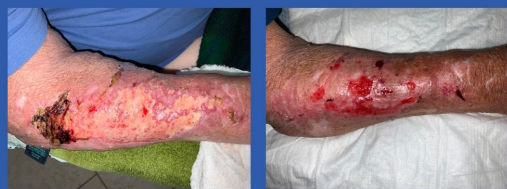
Pt #1 – 74 y/o gentleman presents with a right forearm trauma/skin tear due to a fall on 1/17/24. 1st visit with HP 2/8/24 minimal – non measurable signs of healing with standard of care. Fluorescence Imaging (-) for bacteria >10⁴, & NIRS imaging greater than 80% StO₂. Initiated Amnion Membrane Allograft after 5 applications patients wound is 95% healed
