Open Midfoot Fracture/Dislocation Wound Healed with a Fish Skin Graft

Northern Illinois Foot and Ankle Specialists, Crystal Lake Illinois

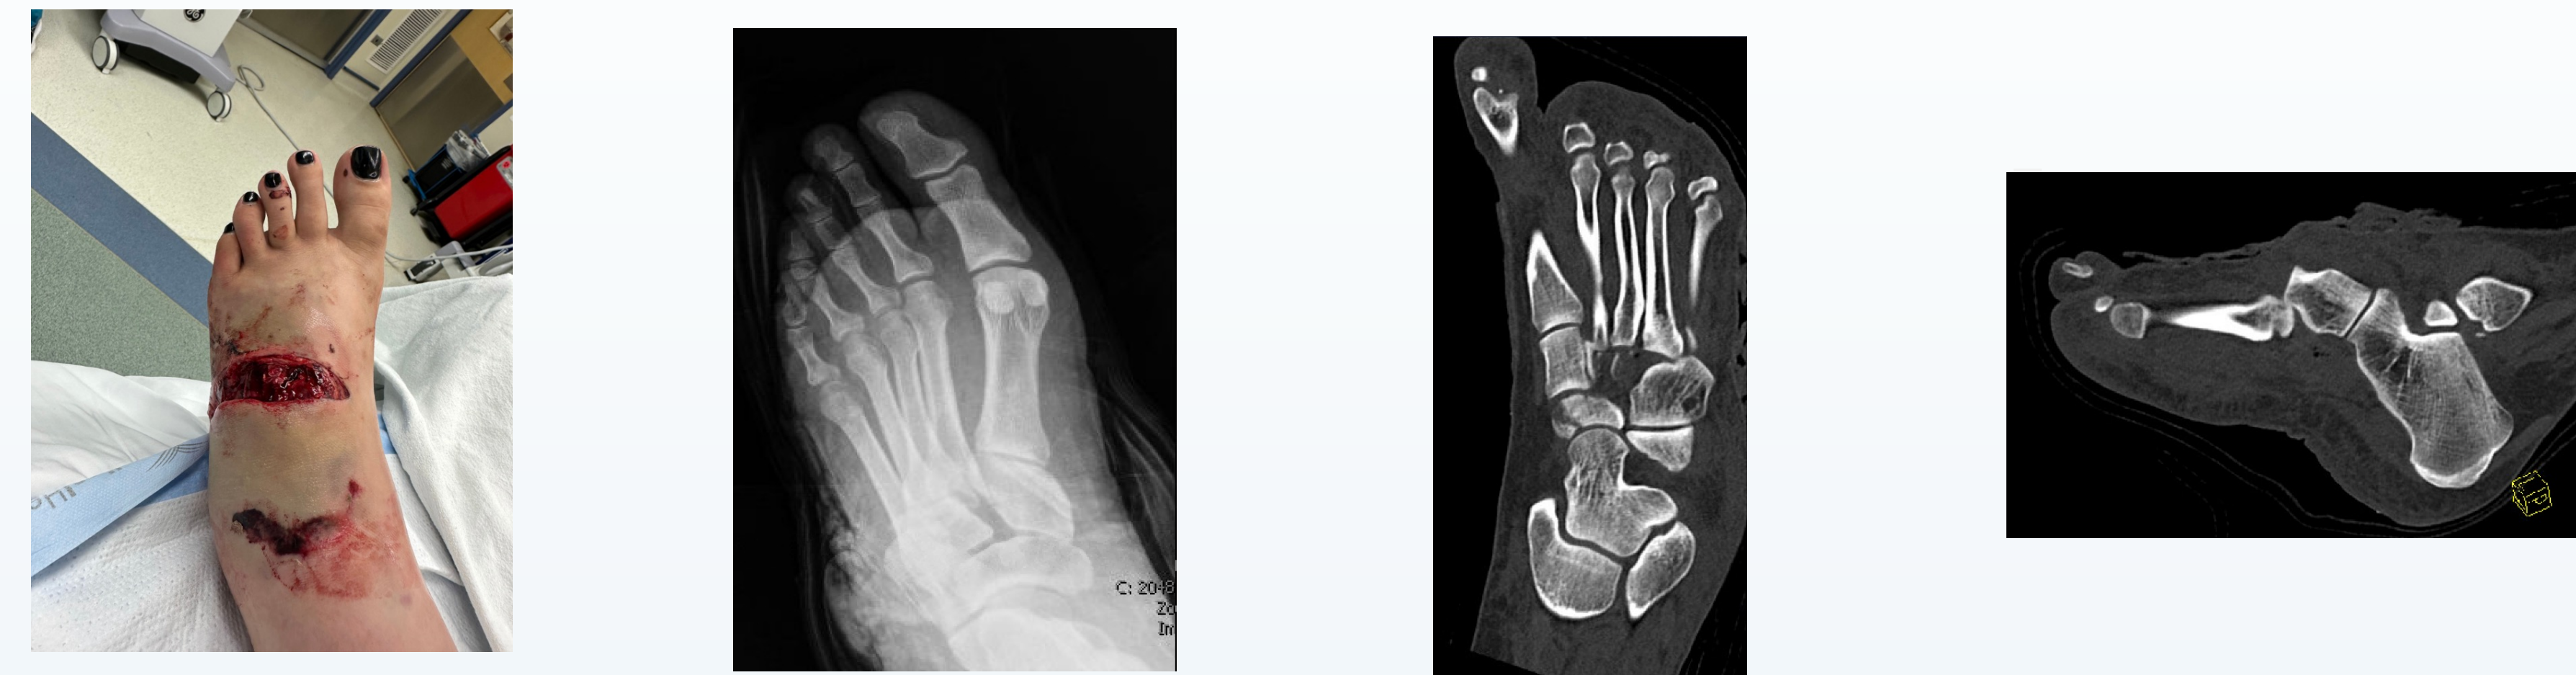
Figures A-D: Patient presented to ED with open fracture of the the left foot. Numerous fractures including a fragment of the posterior malleolus, fibula, navicular, medial and intermediate cuneiform, along with the base of the second and third metatarsals as seen on radiograph and CT scan.

A 30 year old female presented to the emergency room following a car accident with an open fracture of her left foot. She had numerous fractures including a fragment off of the posterior malleolus of the tibia, fibula, navicular, medial and intermediate cuneiform along the the bases of the second and the third metatarsal bones. Initially, the patient was taken to the OR for debridement of the wound and reduction of the fractures. The fractures were reduced and pinned. The soft tissue defect was unfortunately unable to be closed primarily at the time. An application of a skin substitute was applied 3 days later for coverage of the soft tissue defect. The wound was a total of 39 sq cm. A second Fish Skin substitute was applied 11 weeks later for a total surface around of 21 sq cm. The patient was able to heal the wound in just under 4 months.

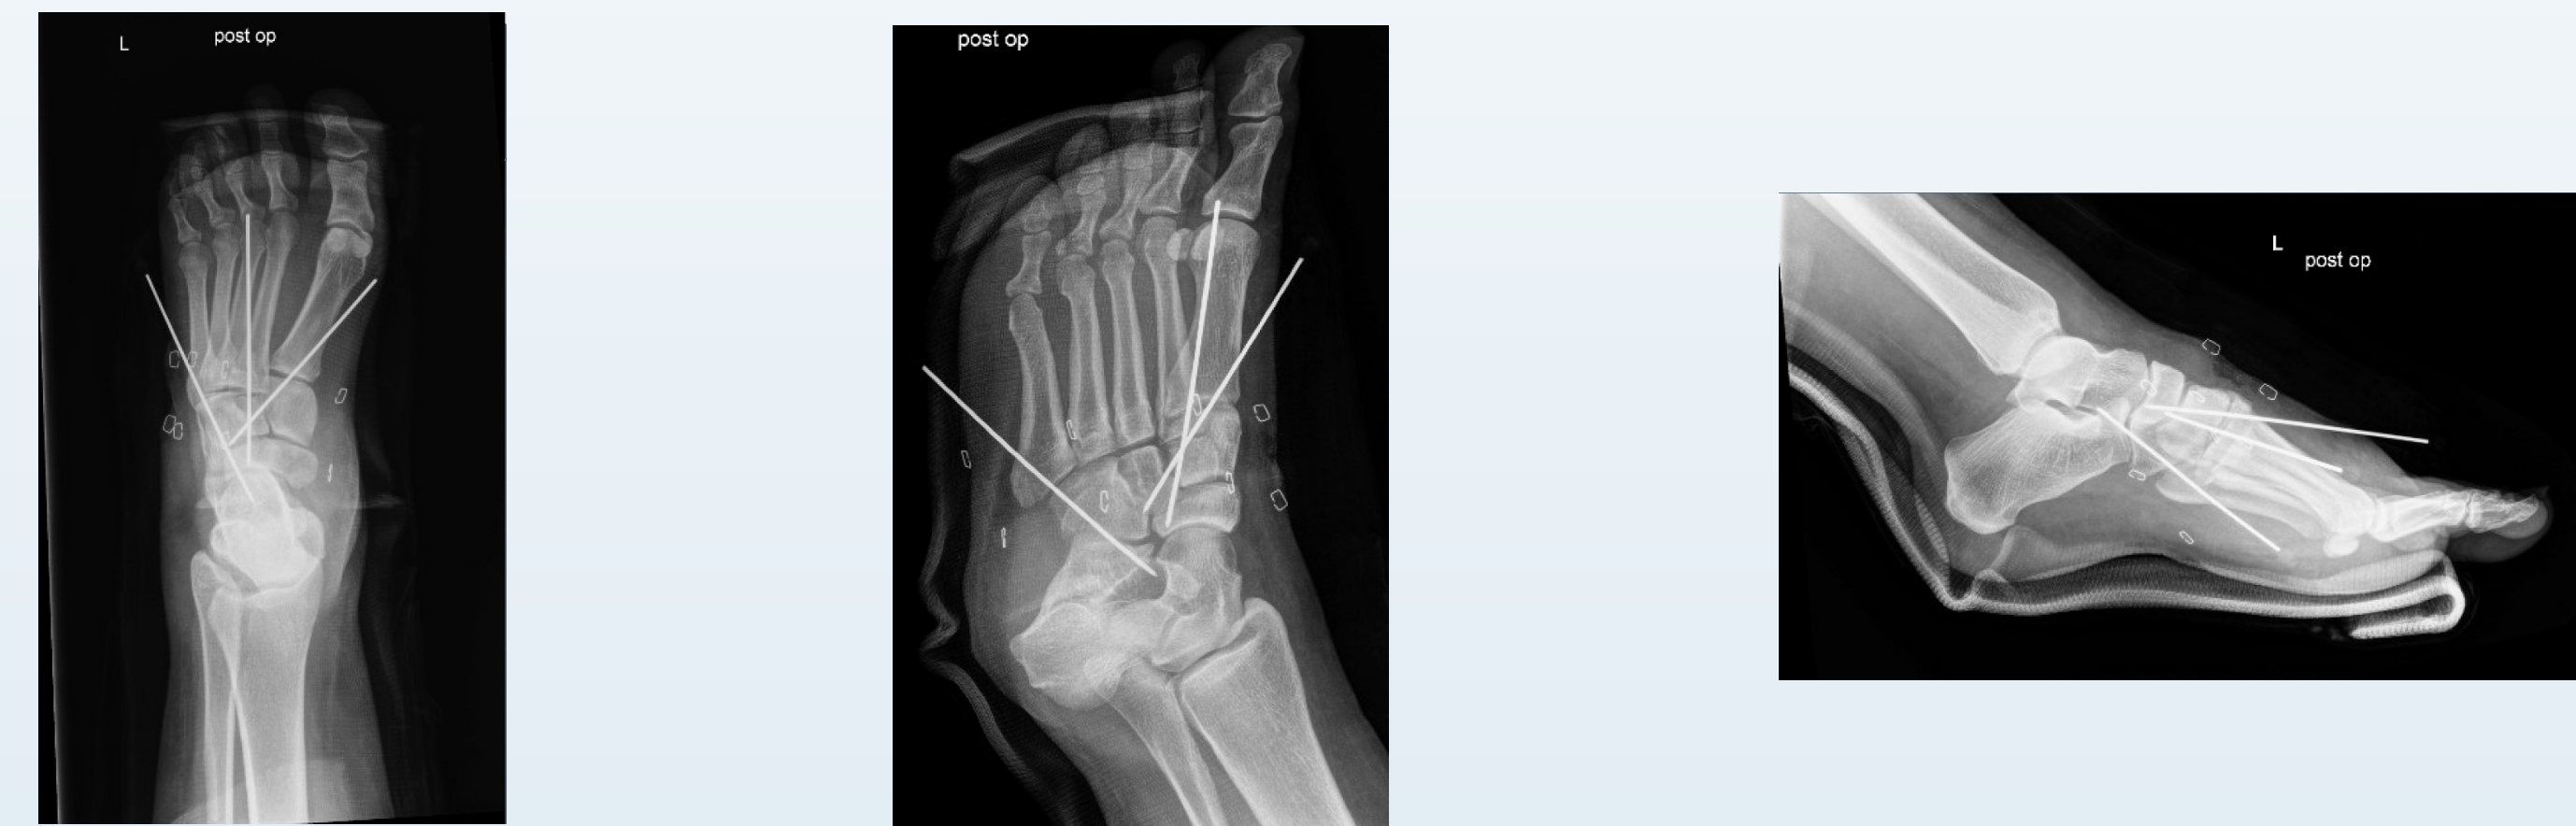
Figures E-G: Post Reduction Films

Open fractures pose a number of potential risks and complications, especially the risk of infection and potential for exposed hardware. In this case, we were unable to achieve primary soft tissue closure at the initial time of injury. The fractures were reduced and pinned in the OR to avoid placing hardware with an open wound. The patient underwent two applications of Fish Skin Substitute and was able to heal the wound in under 4 months without developing an infection. She was also able to heal her fractures in anatomic alignment. This is a successful case of a patient with an open fracture that was unable to be primarily closed at the time of injury due to critical soft tissue defect that was healed using Fish Skin Substitute.

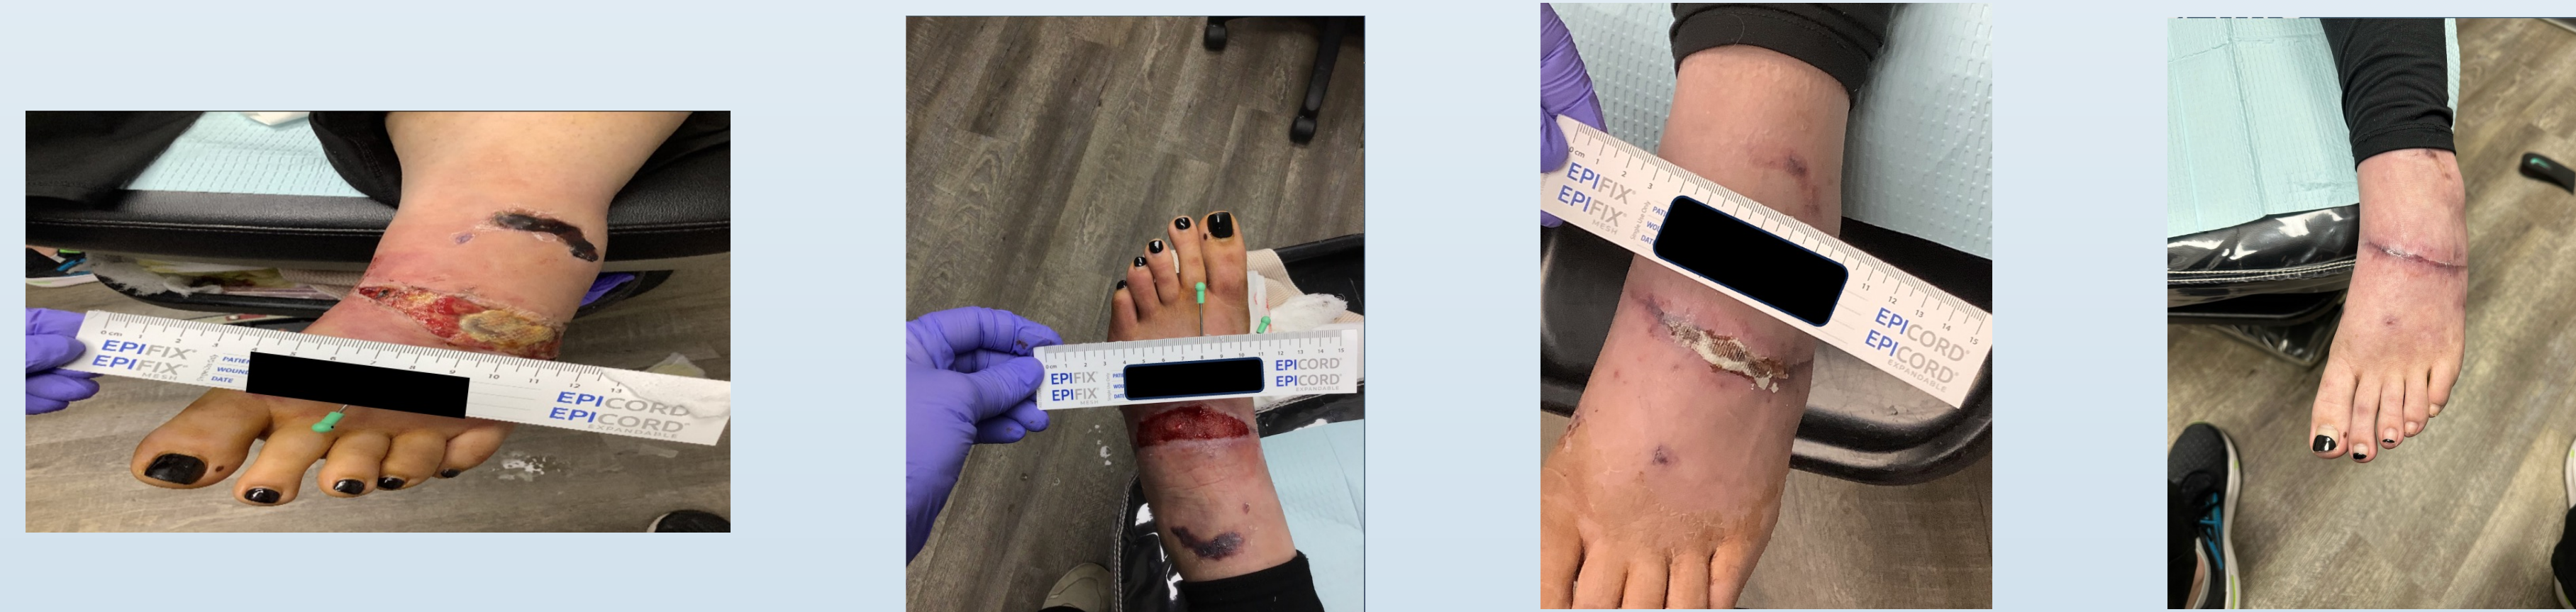
Figures H-J: Wound progression during and after 2 applications of Fish Skin Substitute. Figure K: Final picture of patient healed in under 4 months.
