# Are Compromised Support Surfaces a Vector for Transmission?

Tochukwu Ikpeze, MD; Jay Hamilton, MHL, RN, CSPHA, CPPS, CWS; Gregory Manista, MD

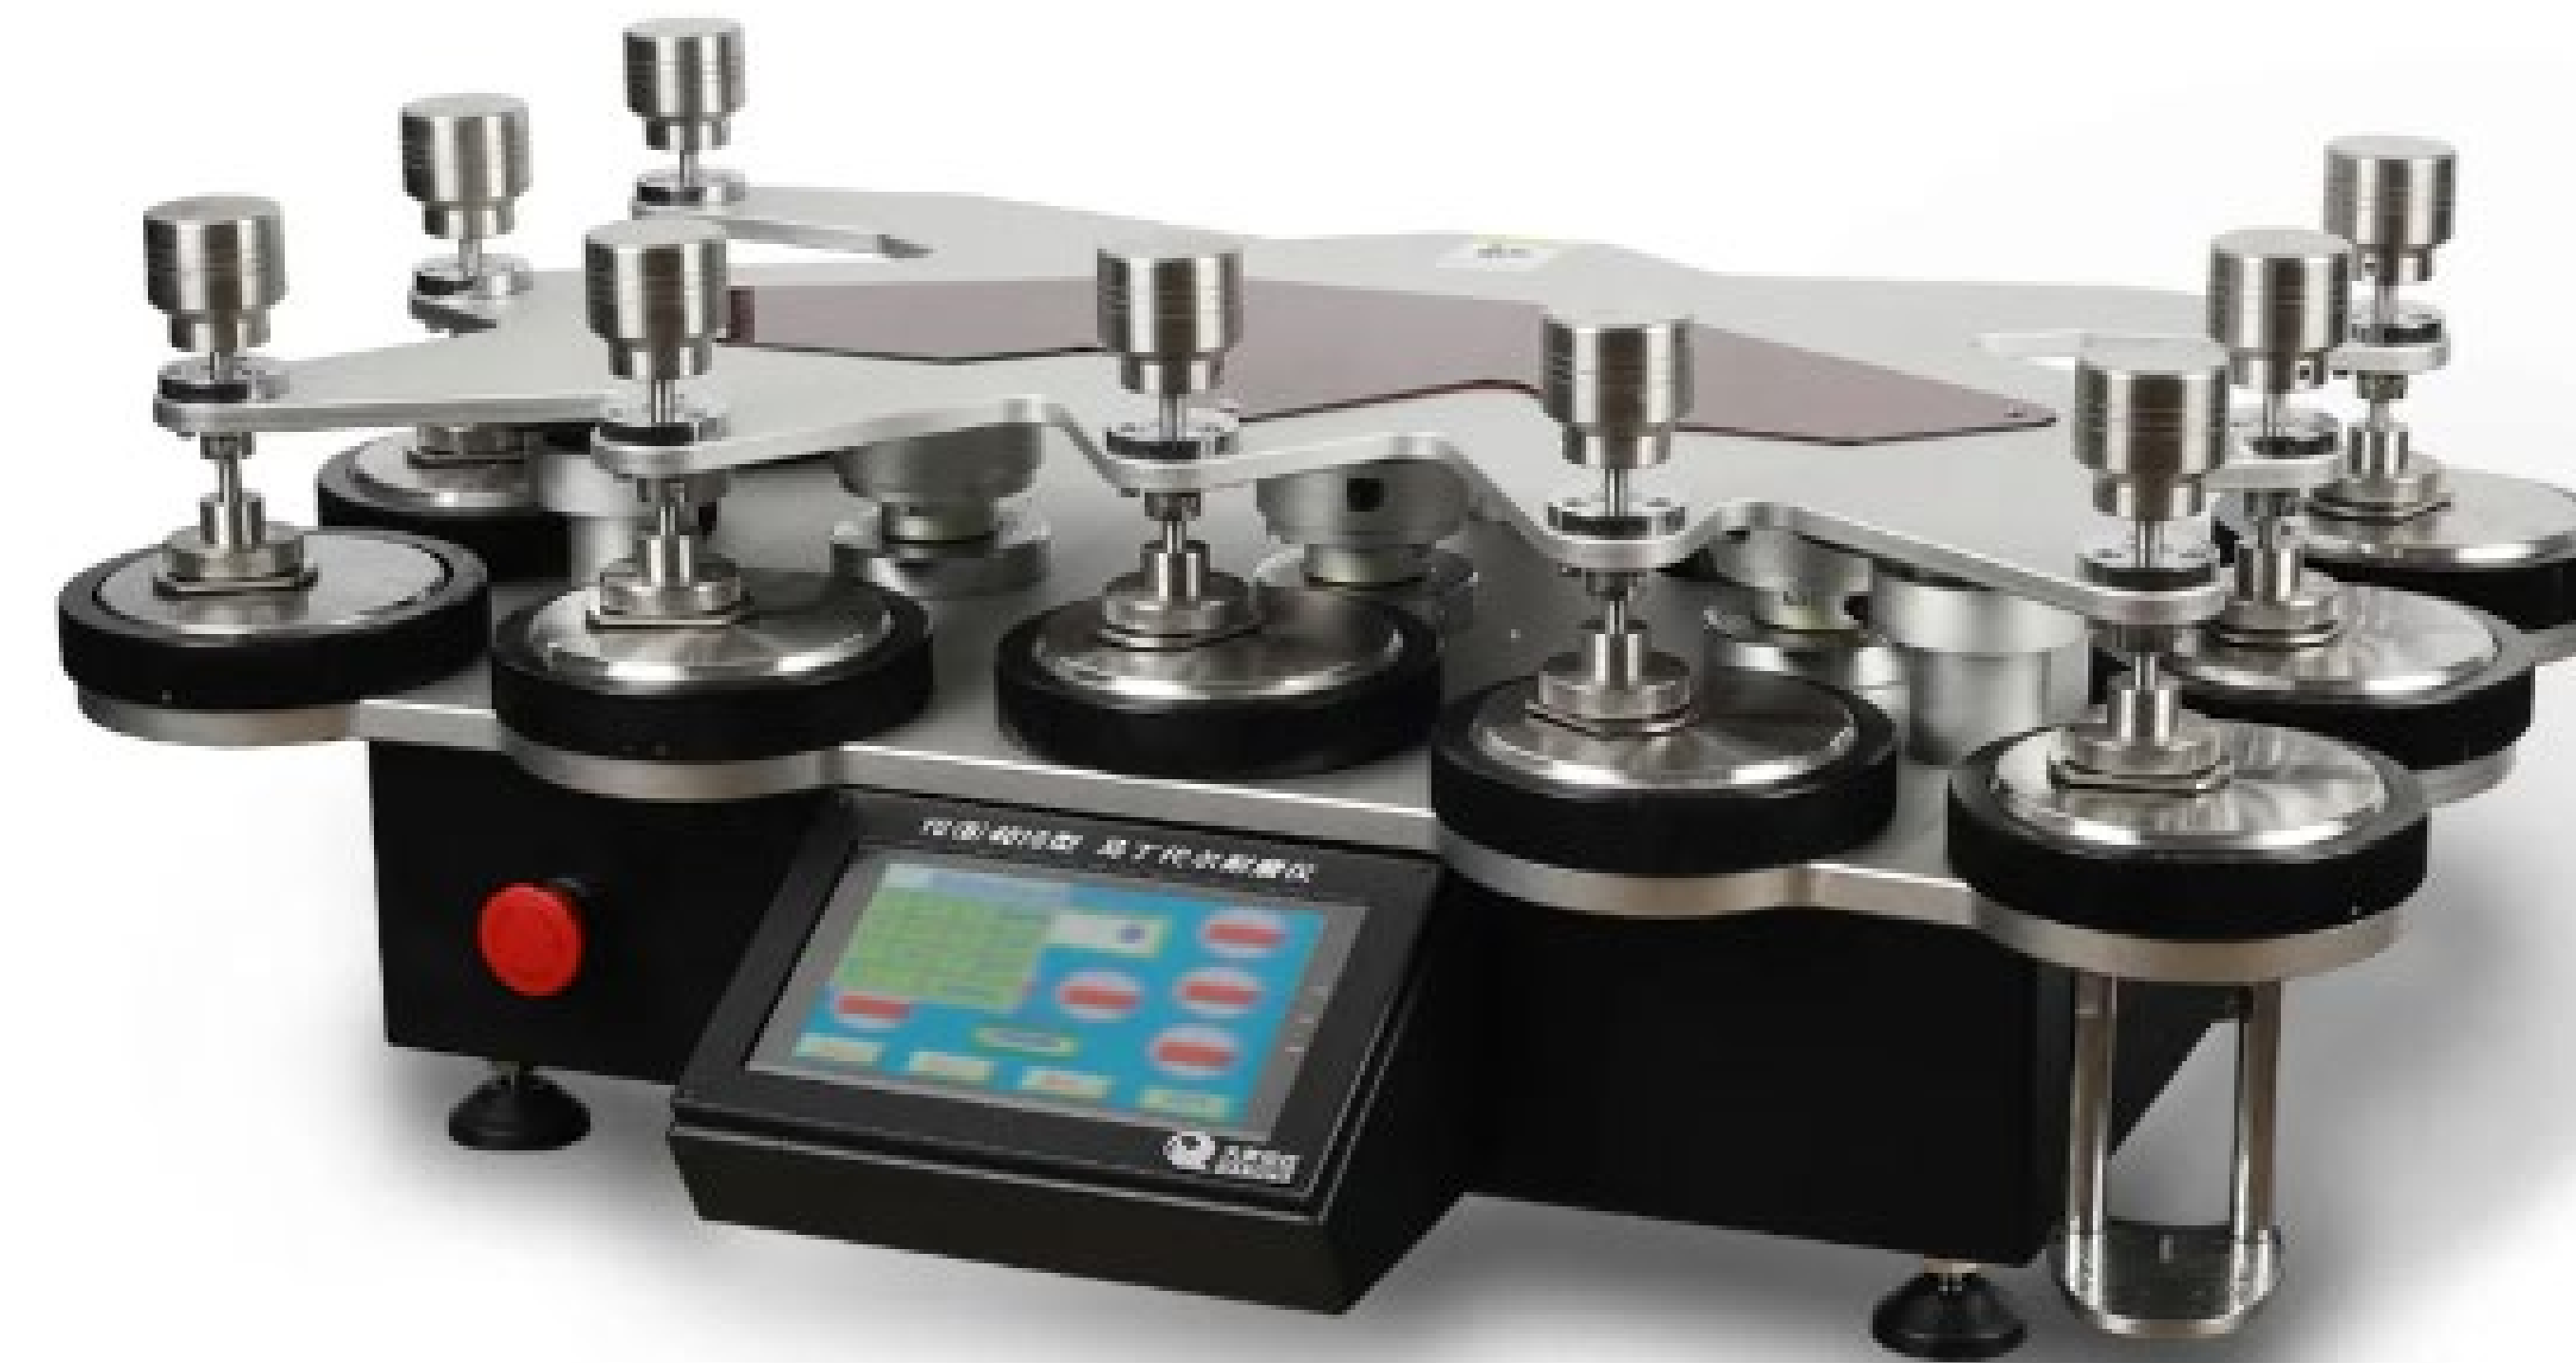
Figure 2: Martin Dale Fraying test to simulate 175,000 rub cycles.

- Utilizing Wet Bacterial Penetration (WBP) testing it was determined that “non-disrupted” surfaces (no tears, frays, abrasions, or any other disruptions to the manufacturer’s design) were impervious to fluid.
- Provided that the support surface was impermeable, the team employed the Martin Dale Fraying test in further attempts of surface disruption.
- Utilizing the Martin Dale Fraying test, a simulated 175,000 rub cycle was completed on the support surface cover.
- The choice of 175,000 rubs was used to simulate cleaning cycles based on the average amount of OR cases in a OR Table pads normal life-cycle (3 years): 10,452 cases. (67, SD=14 case per weekday)<sup>2</sup>.
- After this simulated rub cycle, the surface remained intact.
- As, such, the team then made incisions of varying sizes (.25", .5", .75", 1", 2") and reperformed the WBP testing.
