An Interdisciplinary Approach to Combatting Aeromonas Bloodstream Infections in Dialysis Wall Boxes

Aim Statement

Using a multidisciplinary team approach, the goal of this project was to identify and mitigate engineering, environmental, and nursing factors that may have contributed to hospital-acquired, CRRT-related bloodstream infections in a Transplant/Surgical ICU in 2023

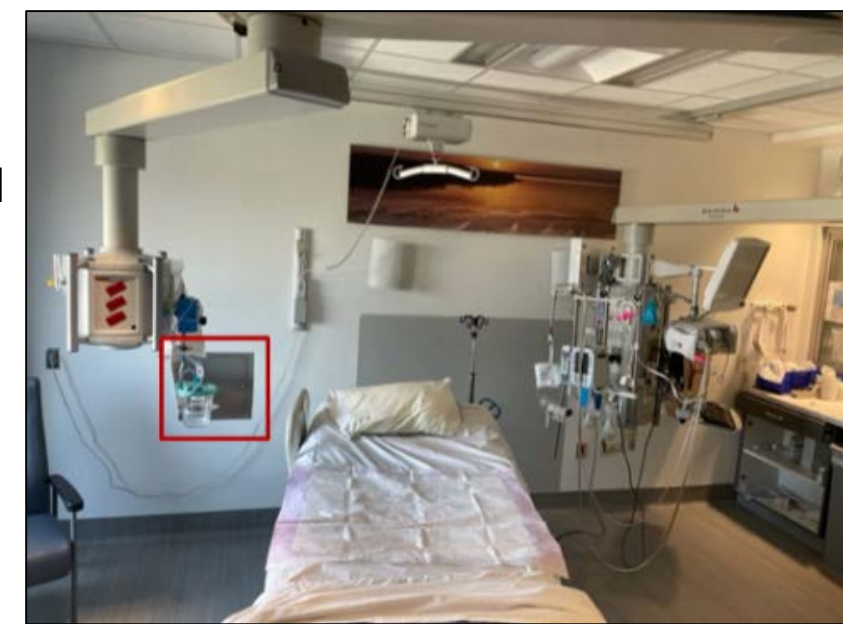
Figure 1. ICU room. Dialysis wall boxes (red box) are frames recessed into the wall that house drainage lines to discard effluent (i.e. spent dialysate or waste) into the sanitary sewer system.

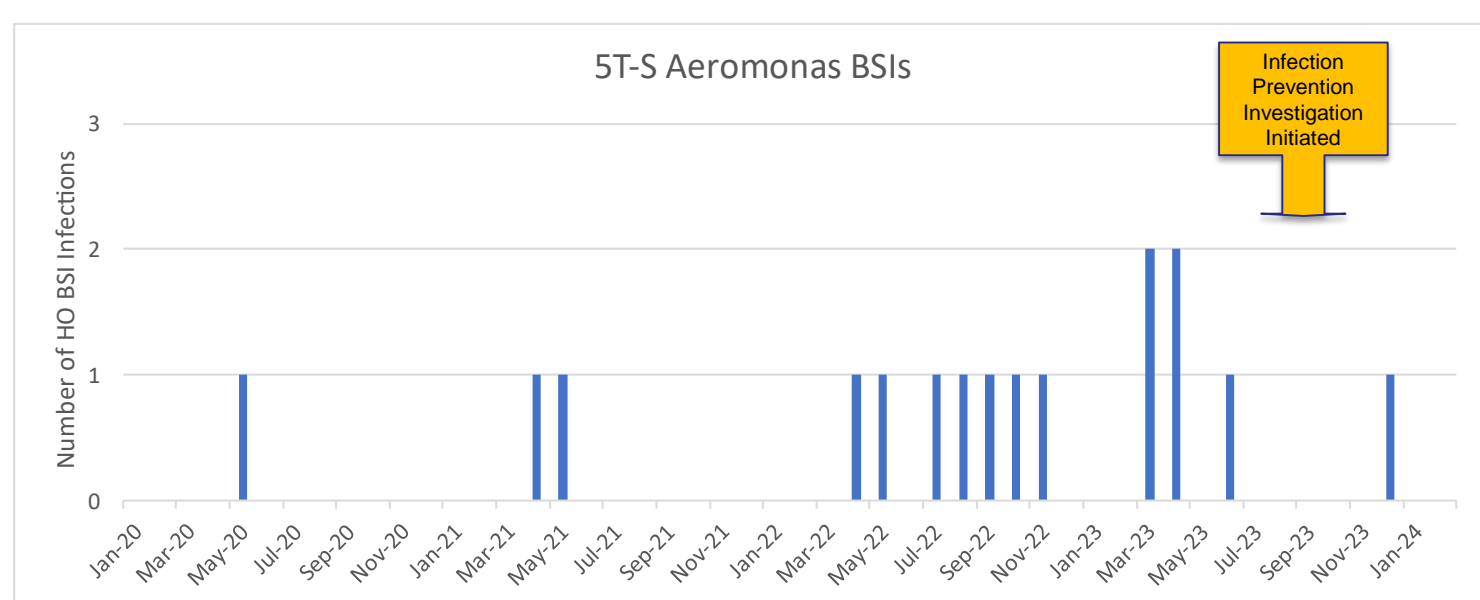
- A retrospective review identified 16 patients cared for in the Transplant/Surgical ICU between January 2020 – December 2023 that developed an Aeromonas bloodstream infection.
- Of these 16 patient, 16/16 were receiving continuous renal replacement therapy (CRRT) via central venous dialysis catheter, 15/16 had severe hepatobiliary disease, and 1/16 had a kidney transplant and was on immunosuppressant medications.
- Environmental testing previously performed failed to identify a definitive source of Aeromonas.

Figure 2. Number of Aeromonas bloodstream infections between January 2020 – December 2023.

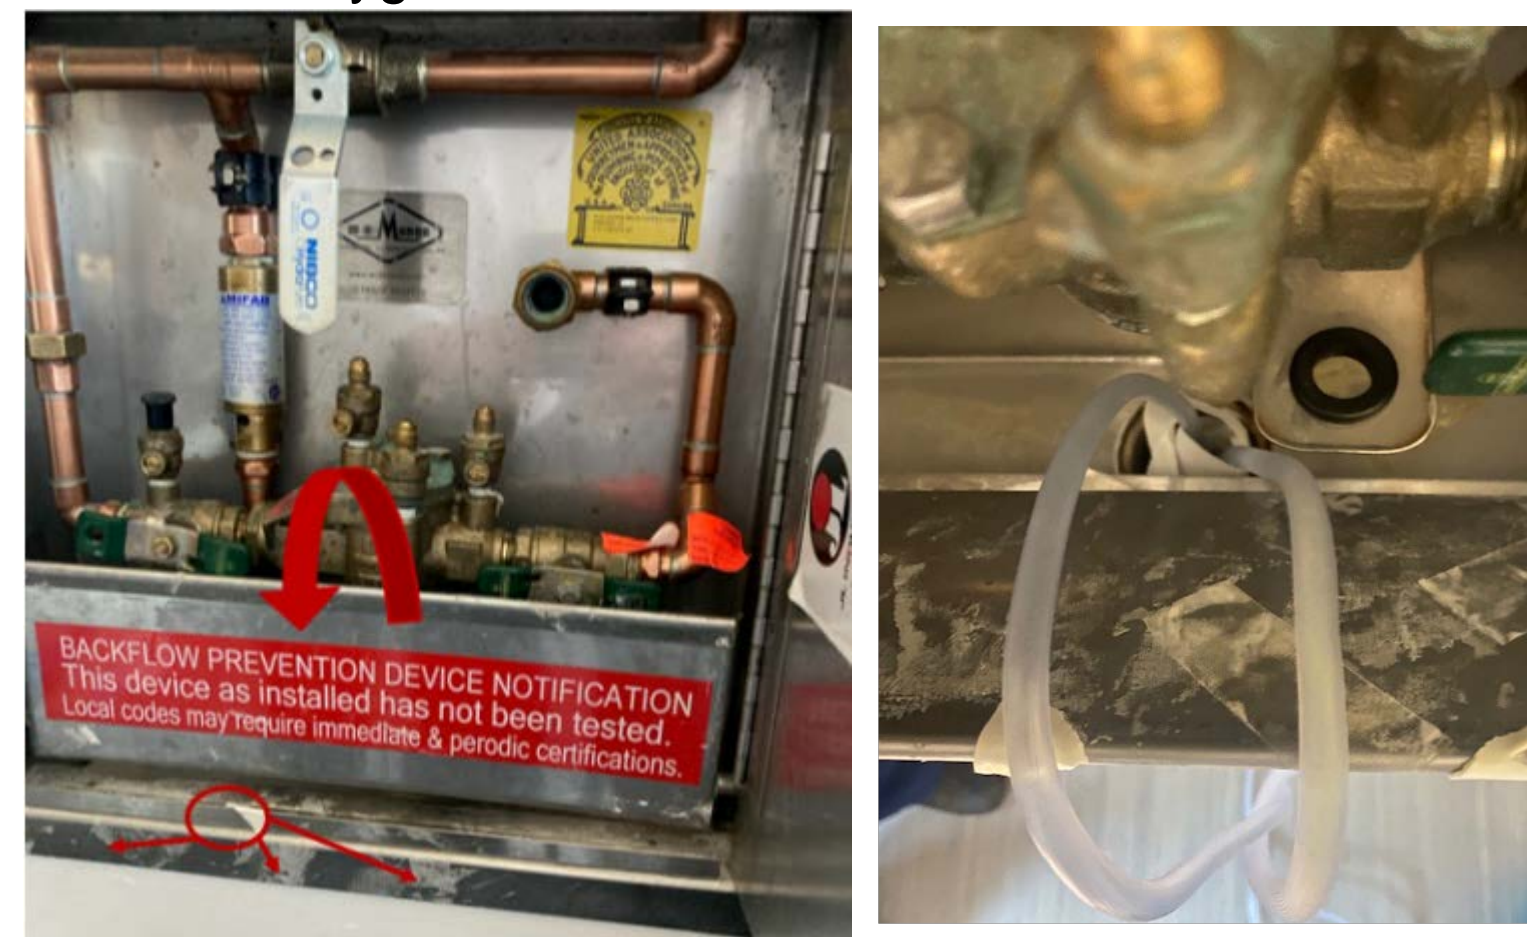
- Tape residue in drain boxes increases risk of biofilm growth.
- Effluent tubing not always placed at 12-18" depth.
- No established wall box and drain cleaning protocol.
- No hand hygiene reminder near wall boxes.

Figure 3. (left) Dialysis wall box with door opened and visible tape and adhesive residue and fold-down drip tray up. (right) Top view of wall box with effluent tubing threaded down drain and secured by staff with tape.

- All tape residue removed from dialysis wall boxes, tape use discouraged.
- Double grommets installed by Facilities Management to secure effluent drain lines without use of tape.
- Hand hygiene reminders placed above every wall box.

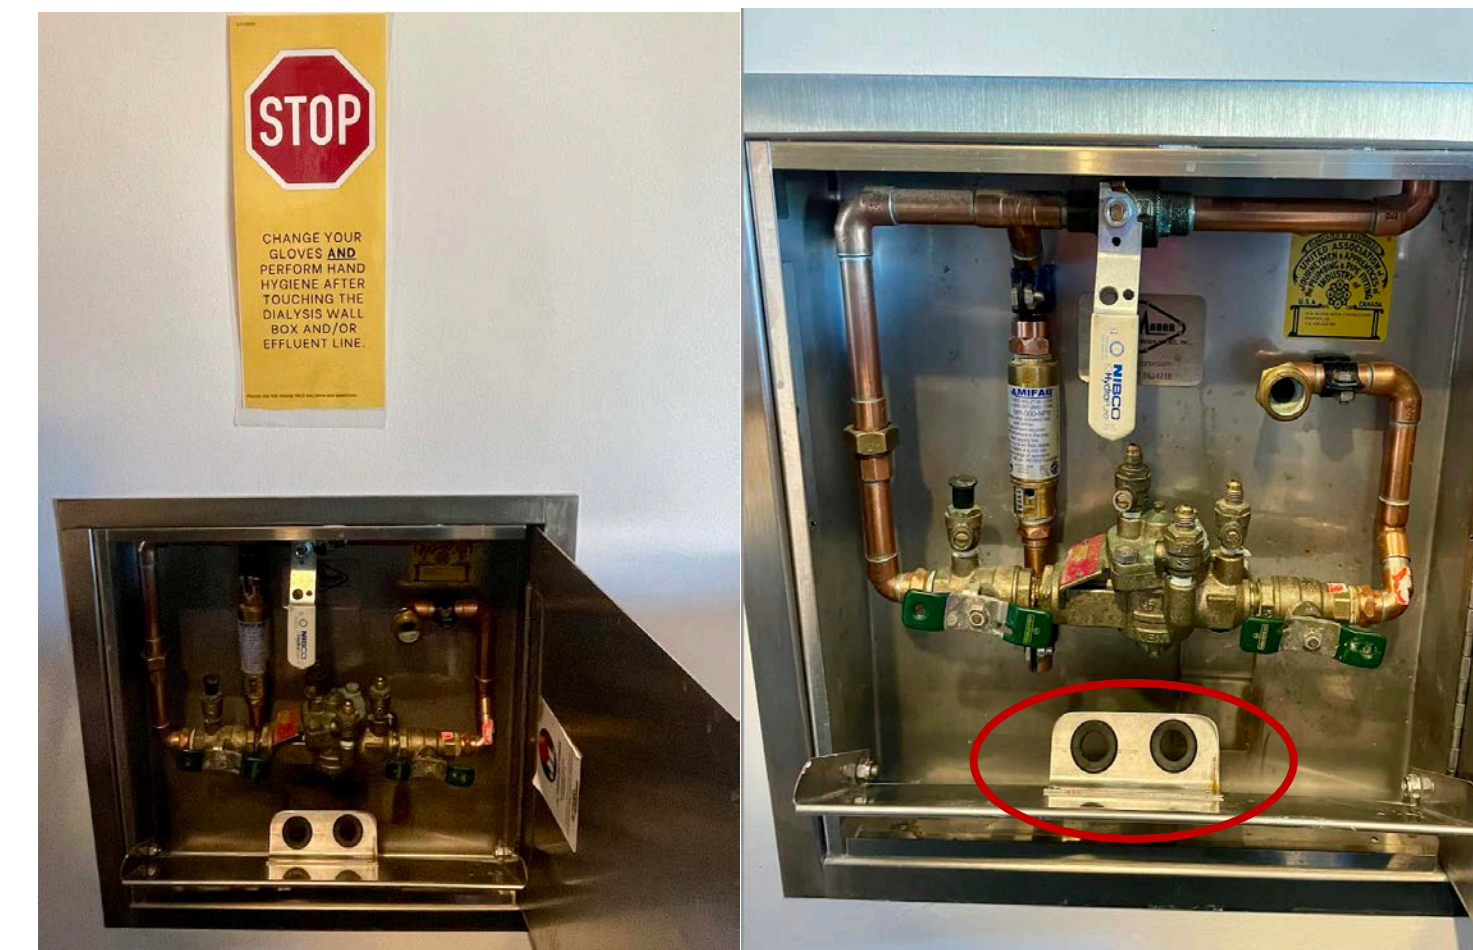
Figure 4. Reconfigured dialysis wall box with double grommets.

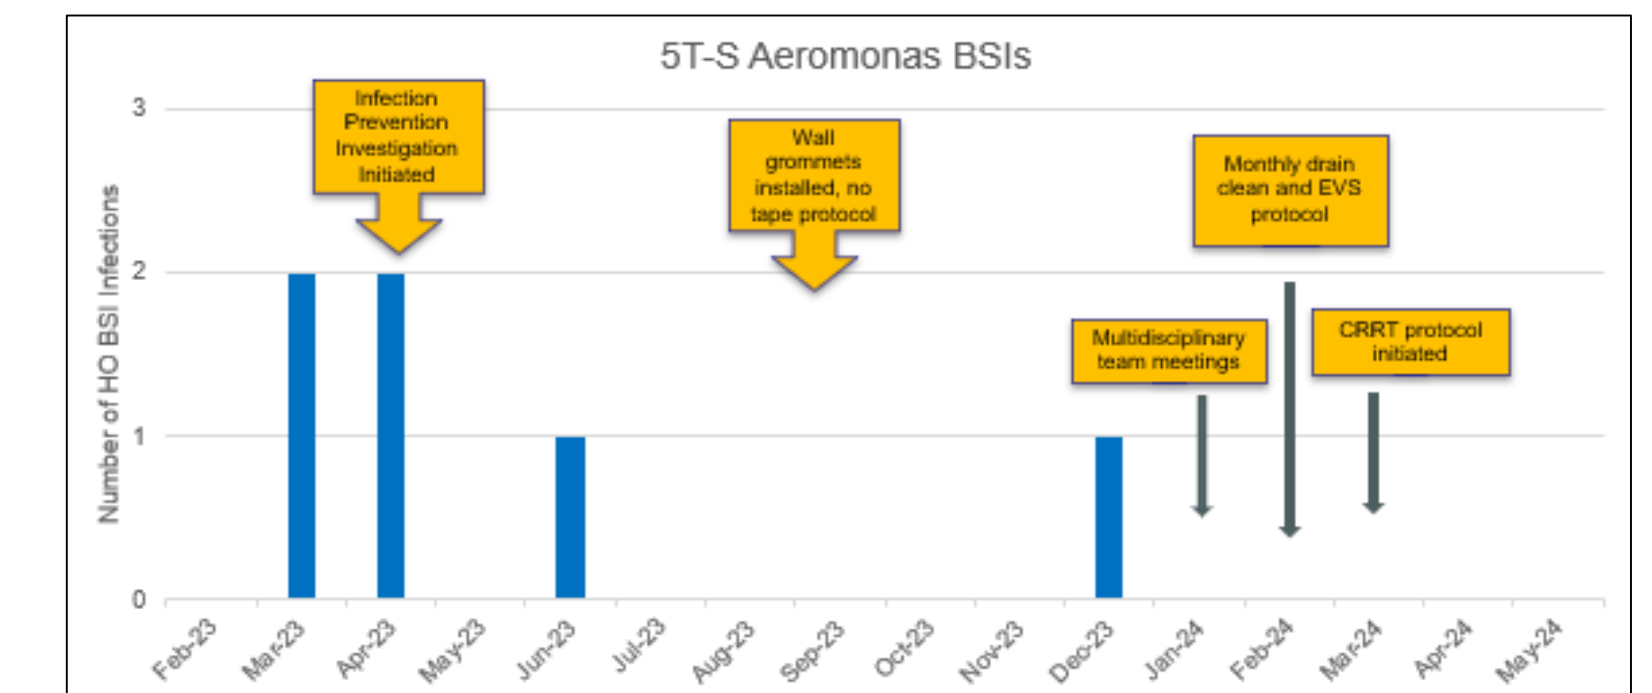
- April '23:** Infection Prevention investigation initiated
- August '23:** Double grommets installed in every dialysis wall box, no tape protocol begins
- Jan '24:** Multidisciplinary task force begins meeting
- Feb '24:** Monthly Orkin enzymatic drain cleaning and EVS wall box cleaning protocols begins
- March '24:** New CRRT set-up and take-down protocol enacted
