# Application of fish skin graft\* to salvage a complex foot wound with loss of the majority of the dorsum and heel of the foot resulting from necrotizing fasciitis

Karl R. Stark, MD, FACS, FSVS, David Shanberg, MD, Scott Kujath, MD, FACS, FSVS UMKC School of Medicine, Department of Vascular Surgery, Kansas City, MO

#### CASE: 67-YEAR-OLD MALE NECROTIZING FASCIITIS LIMB SALVAGE

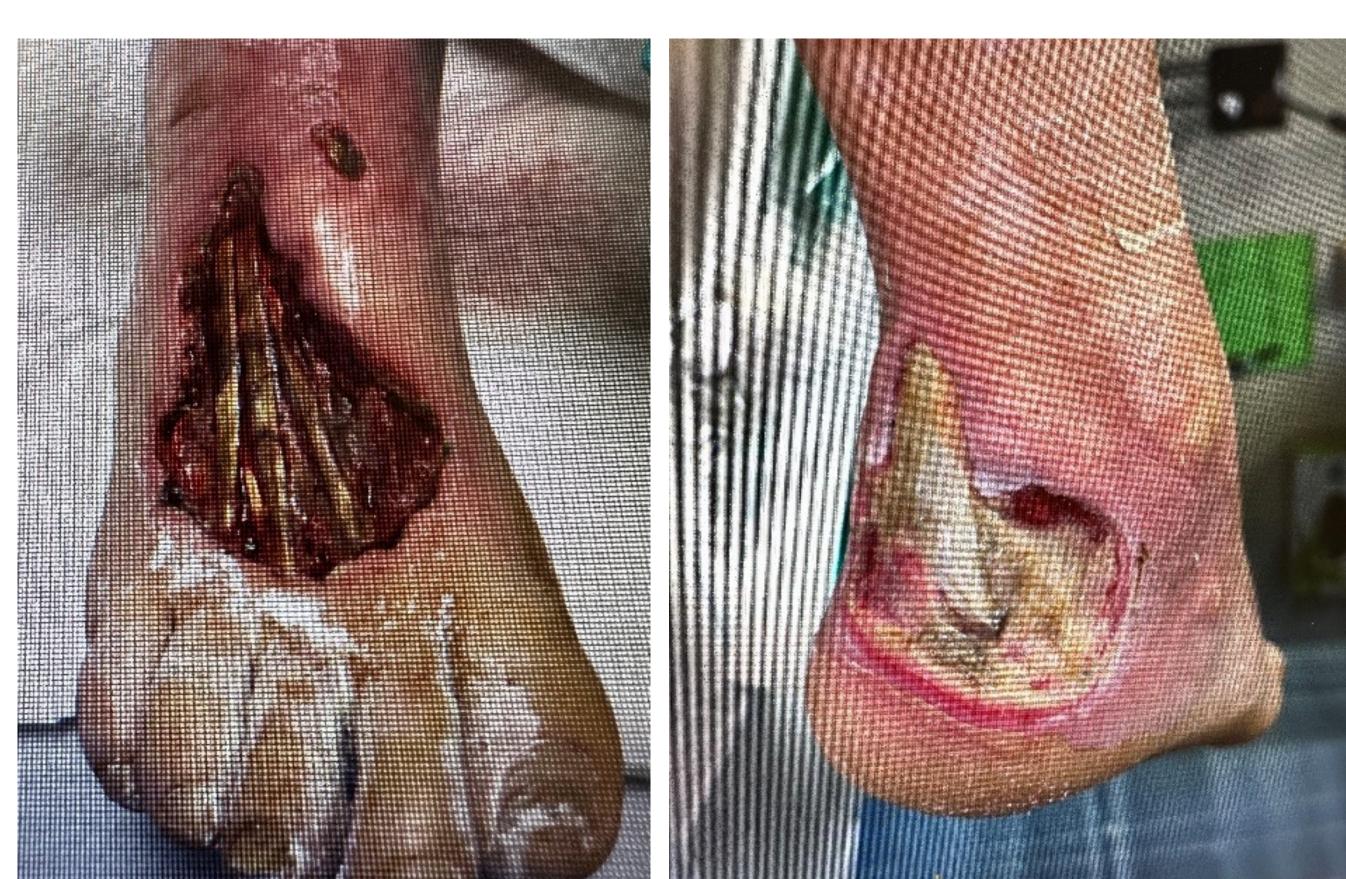
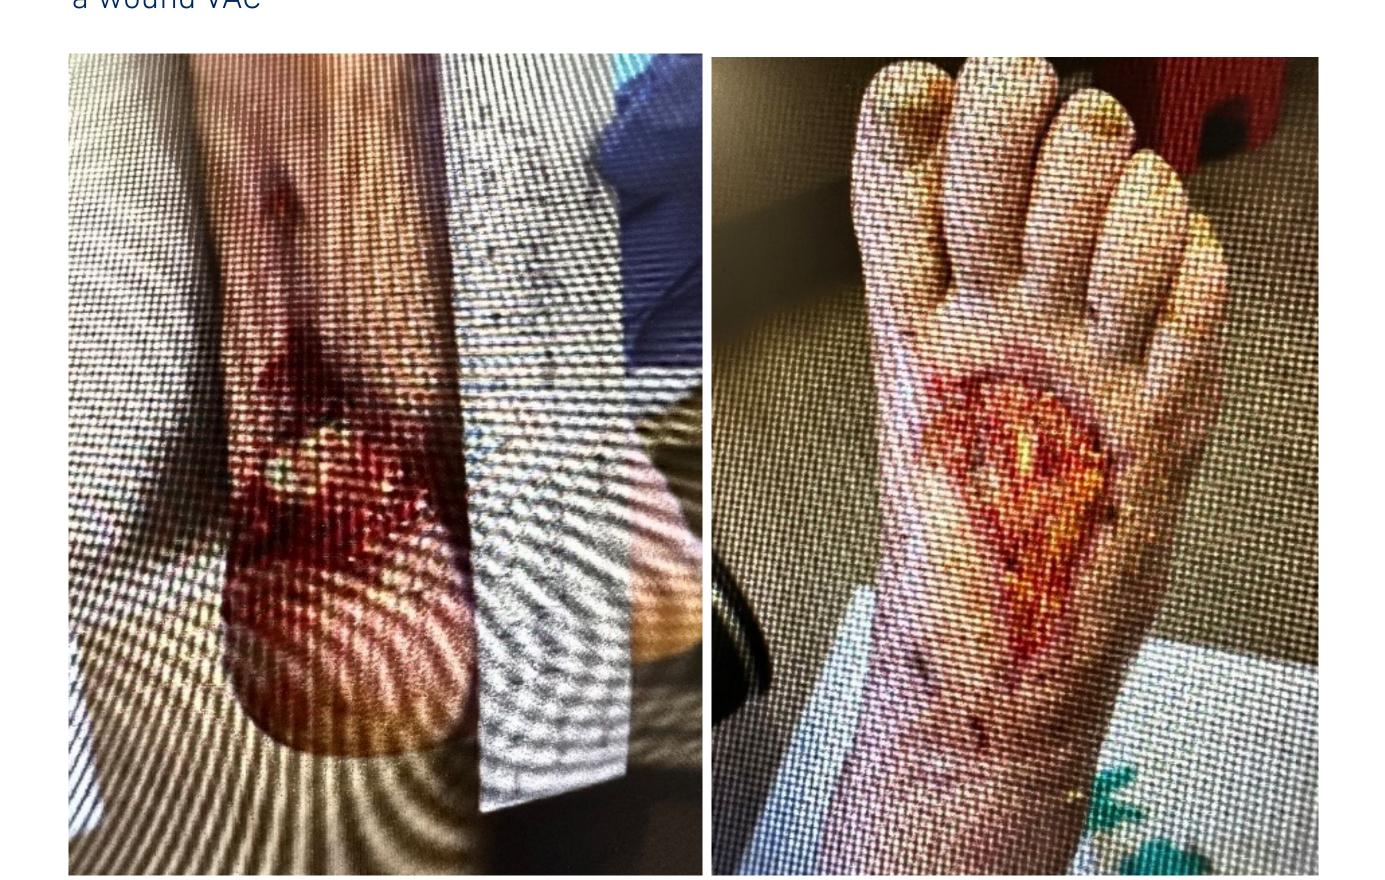
Fourth application of meshed fish skin graft, dorsal tendon area is covered with progressive coverage of the calcaneus and Achilles tendon

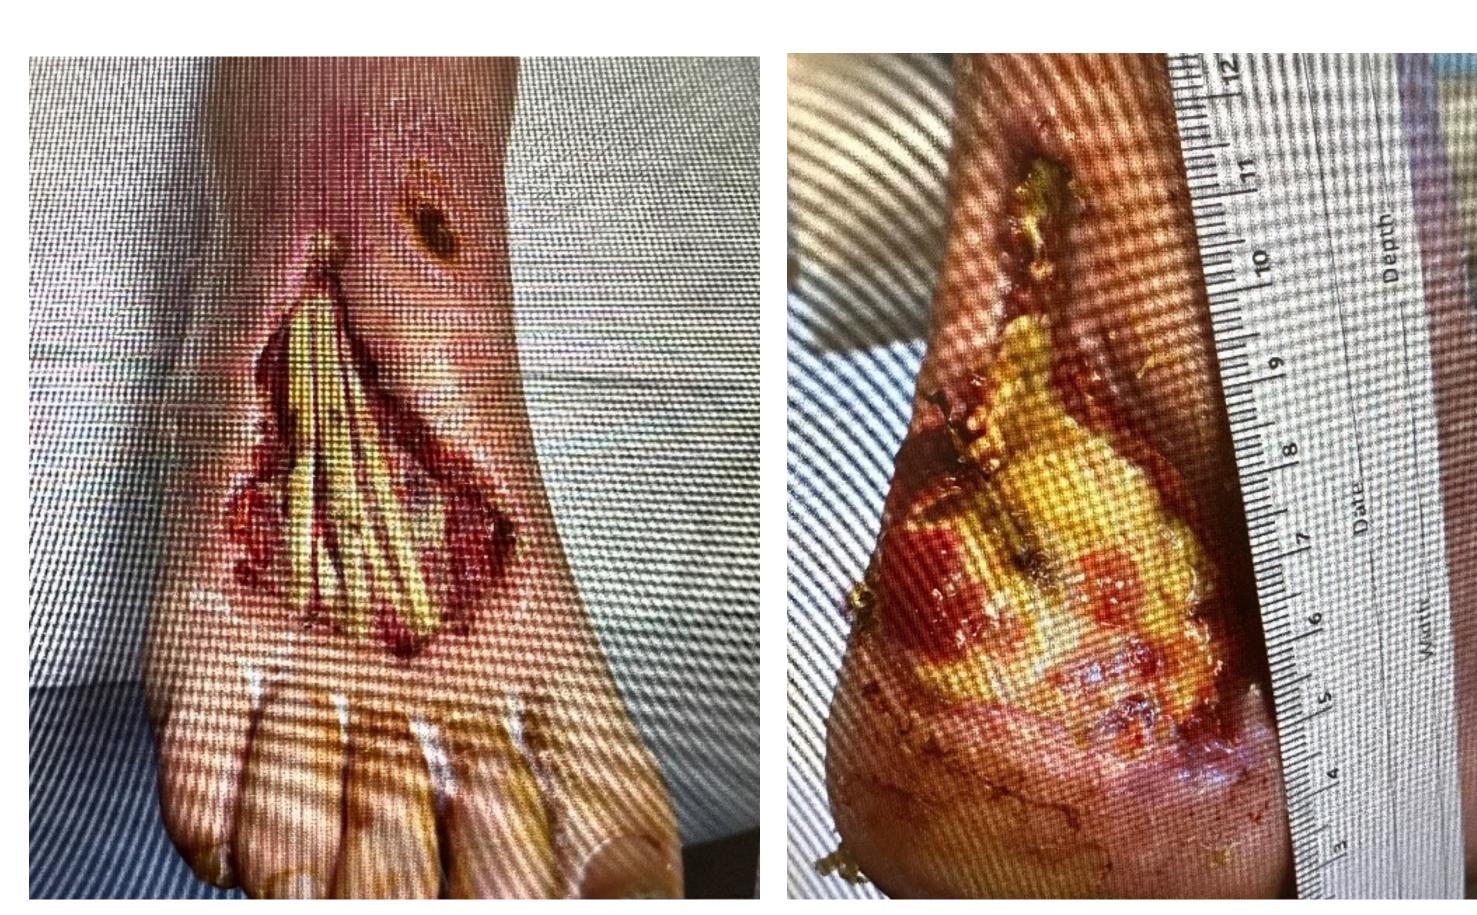
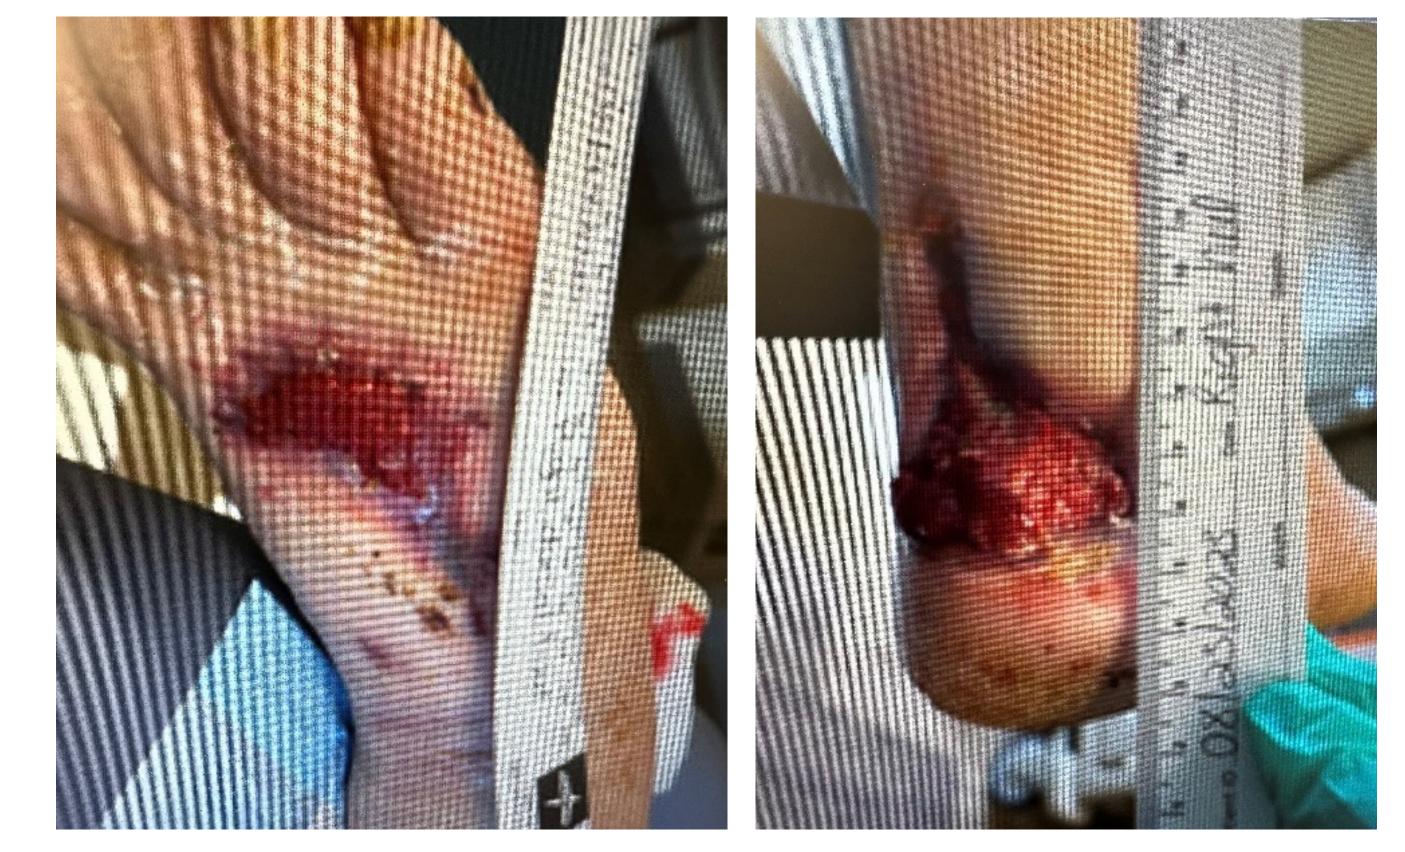
Following additional applications of solid and fenestrated fish skin graft
